## Lessons learned from case histories of reservoirs lined with geomembranes

J.P. Giroud<sup>★</sup>

**Abstract** – Three case histories (in Europe, the Middle East and North America) are used to address some important aspects of the design and performance of geomembrane-lined reservoirs constructed on, or in, soil and rock. After a brief introduction to geomembranes and related geosynthetics, a first case history presents the failure of the liner of a reservoir located on karstic ground. The following lesson was learned: a defective construction detail, combined with an inadequate design (due in part to ignorance of the geological and geotechnical conditions), can cause a catastrophic failure. This case history led to the development of the double liner concept. The second case history is about a double liner. It illustrates the important role played by the mechanical properties of the geomembrane. Geotechnical engineers, who are accustomed to deal with complex materials such as soils and rocks, are well prepared to understand the properties of geomembranes. A third case history shows that a “zero-leakage guarantee” offered by irresponsible suppliers of geomembranes, and believe

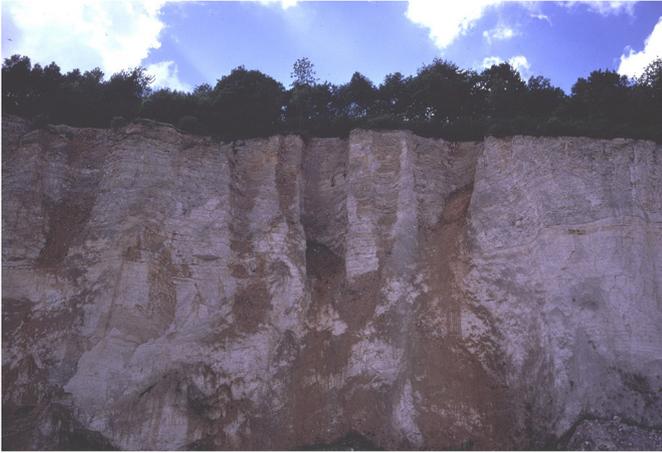
**Fig. 1.** Side view of the karstic formation seen from an abandoned quarry located near the reservoir, which is behind the trees (photo J.P. Giroud).

which provided an opportunity to observe the karstic formation (Fig. 1). Numerous cavities could thus be observed, and it could be seen that the soil layer on top of the karstic formation was relatively thin. A schematic cross section of the site is shown in Figure 2.

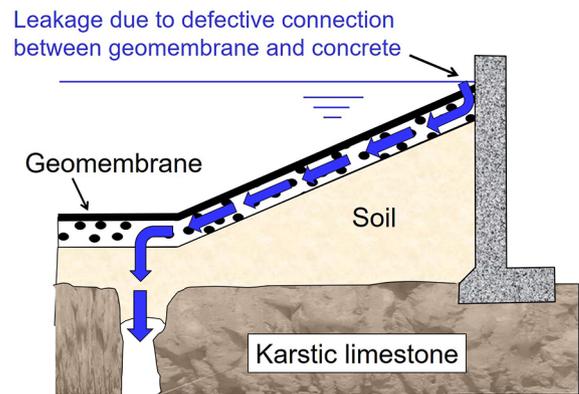
**Fig. 4.** Leakage at a defective connection between the geomembrane and a concrete structure; then, flow of water in the leakage collection and detection layer; and, finally, flow of water into a cavity.

During the first filling of the reservoir, leakage occurred at a defective connection between the geomembrane and a concrete structure (Fig. 4). The leaking water flowed downslope in the leakage collection and detection layer and, at the toe of the slope, reached an area where soil covered and partly filled a cavity, which happened to be near the toe of the slope.

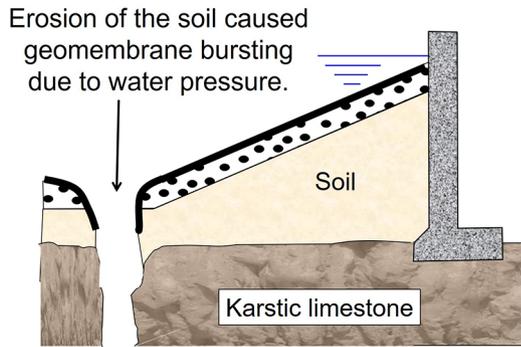
Erosion progressively removed the soil from the top of the cavity. As a result, the geomembrane liner was no longer supported, and it burst over the cavity under pressure from the reservoir water (Fig. 5).

**Fig. 5.** Bursting of the geomembrane over a karstic cavity after erosion of the soil covering the cavity.

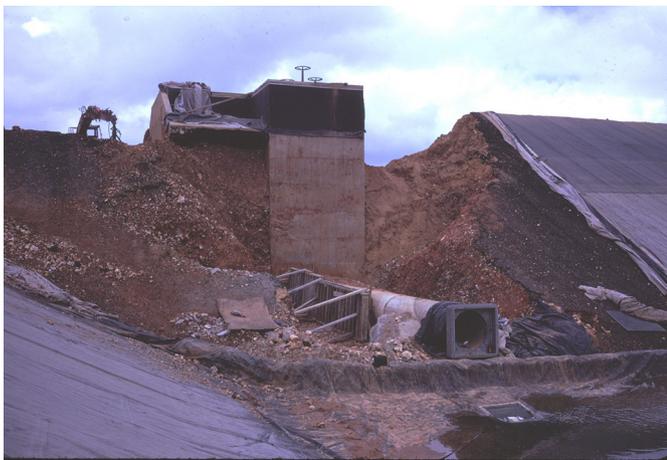
**Fig. 6.** View of the failure area and the concrete structure (photo J.P. Giroud). (Note: The photo was taken several days after the failure. A large piece of geomembrane had been removed by workers. Also, a significant part of the embankment [that was missing around the concrete structure when the photo was taken] had been removed using a crane. Only a fraction of the missing embankment had disappeared into the cavity.)

The geomembrane liner failure caused massive leakage. As a result, the reservoir emptied rapidly through the cavity and several cubic meters of embankment also disappeared into the cavity. A photo taken a few days after the failure is presented in [Figure 6](#).

A defective detail (the leaking connection between geomembrane and concrete structure) triggered the failure. But the main cause of the failure was the lack of geological and geotechnical understanding of the site, which led to a conceptual design flaw: the absence of a liner under the leakage collection and detection layer. With an appropriate conceptual design (*i.e.* a double liner system), a defective detail, the leaking connection between the geomembrane and the concrete structure, should have triggered only a loss of water, not a major failure. It is possible that the negligence at the design stage (*i.e.* the absence of geological and geotechnical study) was caused by excessive reliance on geomembrane “impermeability”.

layer of bituminous concrete reinforced with steel strips. This solution seemed to be based on common sense. However, the consulting engineer hired to investigate the failure (the author of this paper) indicated that the failure had not been caused by lack of strength of the geomembrane but by a design mistake: the extreme sensitivity to erosion by leaking water of the soil underlying the reservoir had not been recognized. The consulting engineer convinced the owner that, because bituminous concrete is not absolutely impermeable, there would be some intrusion of water into the ground and there was a risk of a new karstic collapse. Therefore, the consulting engineer recommended a double liner system.

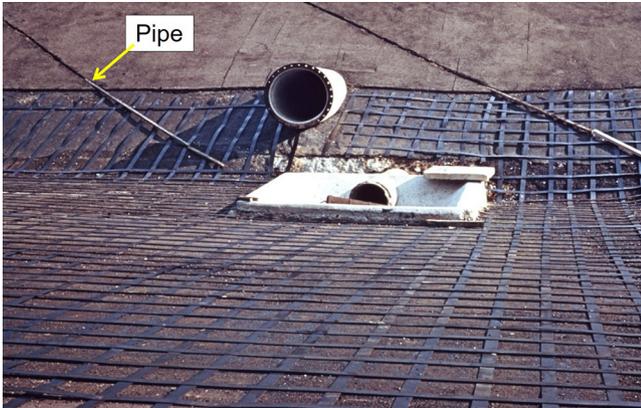
**Fig. 8.** Steel reinforcement used in the secondary liner made of bituminous concrete (photo J.P. Giroud).

between two layers of bituminous concrete: (1) a layer of nonwoven geotextile; and (2) two layers of steel strips at right angle (Fig. 8). While the effectiveness of a nonwoven geotextile reinforcement in bituminous concrete is negligible, the use of two layers of steel strips (of the type used in reinforced earth walls) was probably overconservative. Clearly, the most important feature of the remediation was the prevention of leakage into the ground by a double liner system. In fact, this remediation was the beginning of the development of the double liner concept, which is one of the lessons learned from this case history, as discussed hereafter.

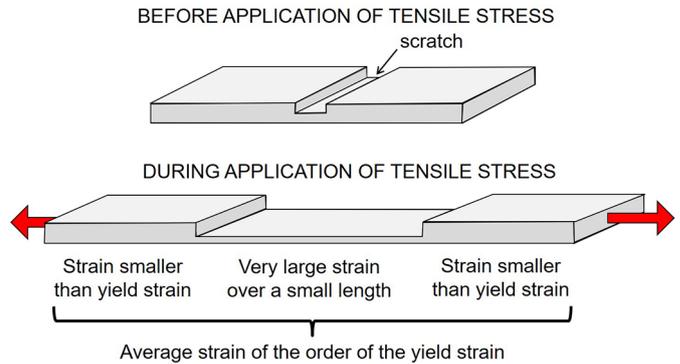
**Fig. 12.** Illustration of localized large strain and thinning of a geomembrane with a yield peak (see Fig. 11) at the location of a scratch at the surface of the geomembrane when it is subjected to tensile forces. (Note: For the sake of clarity of the top part of the figure, the scratch size has been exaggerated; in fact, a very small scratch can initiate the mechanism described above.)

Figure 12 shows that a slight irregularity at the geomembrane surface is sufficient to cause premature rupture of the geomembrane. A stress-strain curve such as the one shown in Figure 11, where rupture occurs at 700% strain, can only be obtained because laboratory tensile tests are conducted in ideal conditions with intact geomembrane specimens having a smooth surface. Such conditions do not exist in the field where the surface of geomembranes always contains a number of small scratches as a result of transportation, handling and installation of the geomembrane rolls.

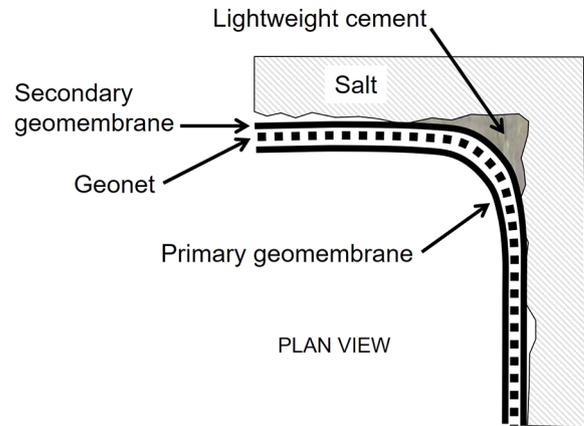
Fig. 14. Lightweight cement poured between the cavity corner and the secondary geomembrane.

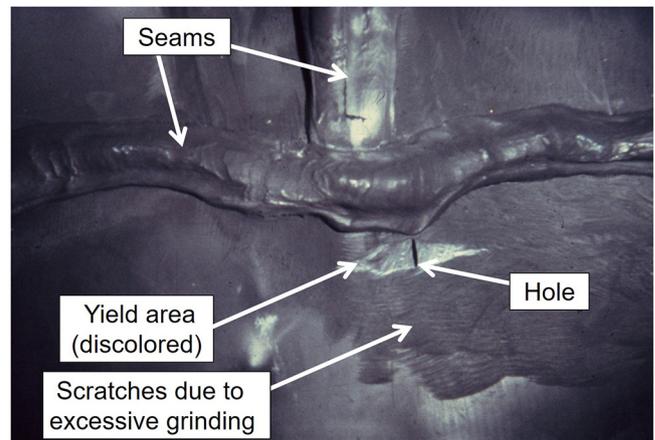
The hole shown in Figure 15 is in a scratched area near a seam. The scratches seen in Figure 15 were caused by a procedure that consisted in grinding the geomembrane surface, prior to seaming, to remove surface impurities. This procedure has been improved since then.

Fig. 15. Underwater photo showing the formation of a hole in the primary geomembrane subjected to excessive strain (Courtesy J.L. Stone).

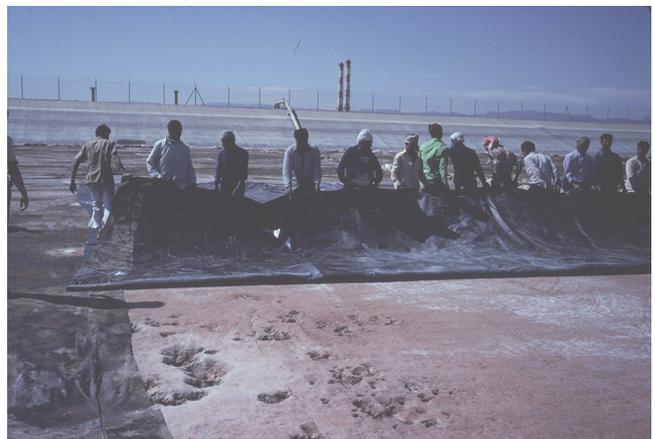
Inspection after the failure showed that the geomembrane had many holes (open seams, punctures, tears) due to careless construction and lack of quality control. It was clear that the geomembrane had to be discarded and that a new geomembrane had to be installed. When the geomembrane was removed, many cavities were found ([Fig. 16](#)).

**Fig. 16.** Cavities in the soil caused by several leaks of acid, discovered when the geomembrane was removed for the failure investigation (photo J.P. Giroud).

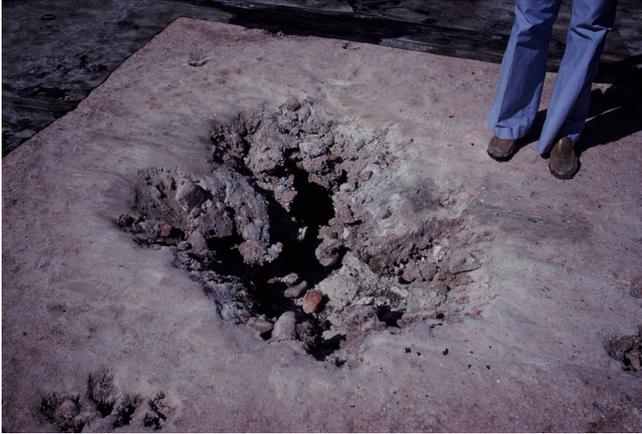
**Fig. 17.** One of the large cavities over which the geomembrane burst (photo J.P. Giroud).
