## Lessons learned from case histories of reservoirs lined with geomembranes

J.P. Giroud<sup>★</sup>

**Abstract** – Three case histories (in Europe, the Middle East and North America) are used to address some important aspects of the design and performance of geomembrane-lined reservoirs constructed on, or in, soil and rock. After a brief introduction to geomembranes and related geosynthetics, a first case history presents the failure of the liner of a reservoir located on karstic ground. The following lesson was learned: a defective construction detail, combined with an inadequate design (due in part to ignorance of the geological and geotechnical conditions), can cause a catastrophic failure. This case history led to the development of the double liner concept. The second case history is about a double liner. It illustrates the important role played by the mechanical properties of the geomembrane. Geotechnical engineers, who are accustomed to deal with complex materials such as soils and rocks, are well prepared to understand the properties of geomembranes. A third case history shows that a “zero-leakage guarantee” offered by irresponsible suppliers of geomembranes, and believe

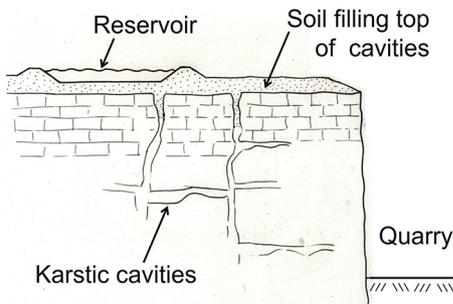
**Fig. 1.** Side view of the karstic formation seen from an abandoned quarry located near the reservoir, which is behind the trees (photo J.P. Giroud).

which provided an opportunity to observe the karstic formation (Fig. 1). Numerous cavities could thus be observed, and it could be seen that the soil layer on top of the karstic formation was relatively thin. A schematic cross section of the site is shown in Figure 2.

Unfortunately, at the design stage, no geological or geotechnical study was performed, and the quarry was not observed by the designer of the reservoir. The quarry was observed only when the failure of the reservoir was investigated. As a result, the designer of the reservoir was not aware of the presence of the karstic formation hidden by a thin layer of soil.

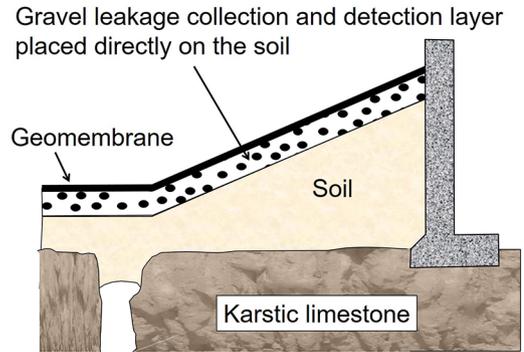
The reservoir was lined with a single geomembrane underlain by a gravel leakage collection and detection layer placed directly on the soil (Fig. 3). This was not an adequate design because a leakage collection and detection layer, placed directly on the soil, cannot prevent leakage into the ground,

**Fig. 3.** Liner system of the reservoir located on karstic ground.

with two possible consequences: (1) the leaking liquid may have a detrimental impact on the ground (e.g. erosion, dissolution, pollution); and (2) leakage detection may not be reliable (i.e. depending on the relative permeabilities of the leakage collection and detection layer material and the underlying soil, the rate of leakage may not be correctly evaluated or leakage may not be detected).

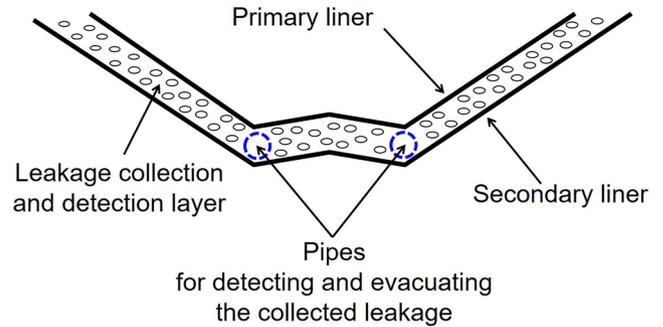
**Fig. 9.** Schematic cross section of a double liner system, which includes not only two liners but also a leakage collection and detection layer. (Note: The leakage collection and detection layer is symbolically represented as made of gravel, but it can also be made of a geosynthetic drainage material such as a geonet, as shown in the next case history.)

Shortly after the above-described remediation, a paper in French (Giroud, 1973) presented the double liner concept. A double liner system consists of two liners (primary liner and secondary liner) separated by a drainage layer acting as leakage collection and detection layer (Fig. 9).

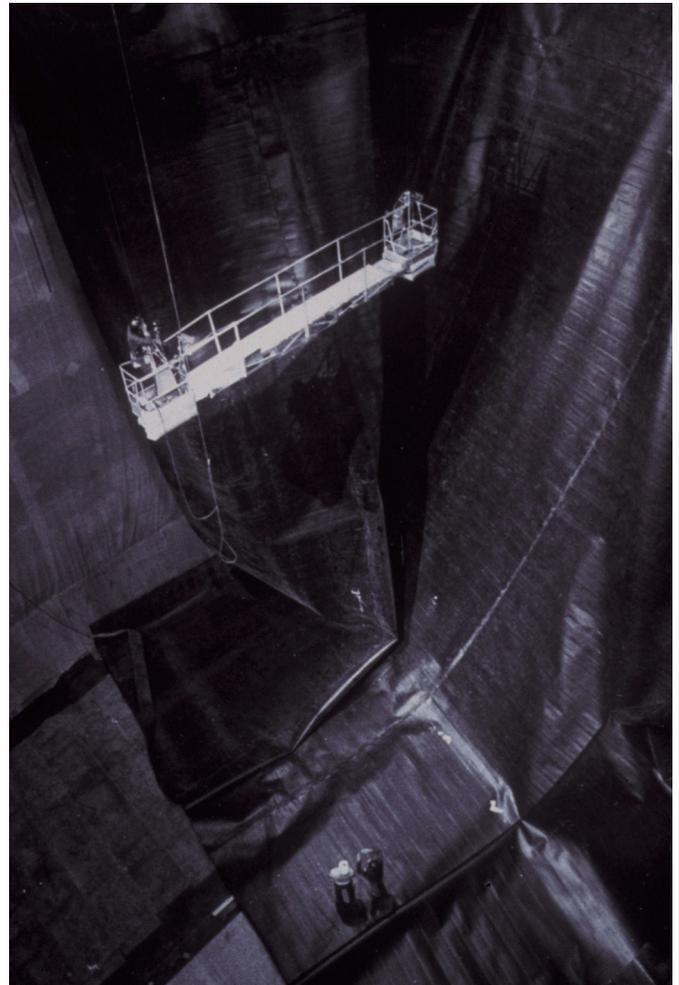
**Fig. 10.** The 20-m deep Proton Decay Experiment reservoir during geomembrane liner installation (Courtesy J.L. Stone).

The salt walls had a very irregular surface. Furthermore, a chain-link mesh was rock-bolted to the walls to prevent spalling of salt. To prevent puncturing of the geomembrane under the pressure of 20 m of water, the following precautions were taken: (1) the selected geomembrane for both liners was 2.5 mm thick, which was the thickest HDPE geomembrane available; and (2) heavy-duty protection, comprising polyethylene plates and reclaimed conveyor belts, was placed between the chain-link mesh and the secondary geomembrane. This protection system was subjected to laboratory testing, as described in Giroud and Stone (1984), and it was effective because the geomembranes were not punctured during the entire service life of the reservoir. However, due to the geomembrane thickness, the liner system was very stiff, which caused significant problems as discussed hereafter.

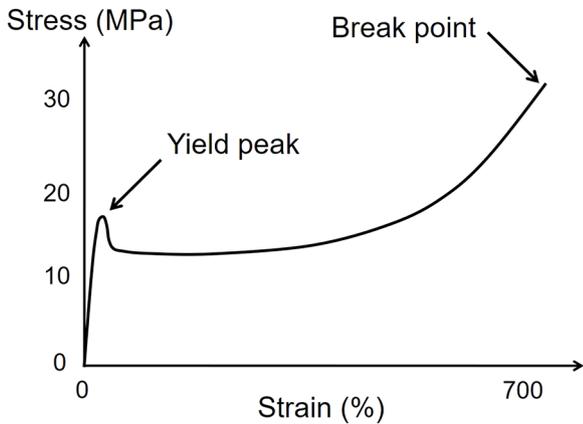
**Fig. 11.** Typical stress-strain curve of HDPE geomembrane obtained from a tensile test.

Upon inspection of the stress-strain curve of the HDPE geomembrane, the design engineer realized that there was a yield peak on the curve (Fig. 11), which was a surprise since no other geomembrane known at that time had a yield peak on its stress-strain curve. The yield peak occurred at a tensile strain of approximately 12%, whereas the strain at break of the HDPE geomembrane (*i.e.* the end of the stress-strain curve) was approximately 700%.

Figure 12 shows that a slight irregularity at the geomembrane surface is sufficient to cause premature rupture of the geomembrane. A stress-strain curve such as the one shown in Figure 11, where rupture occurs at 700% strain, can only be obtained because laboratory tensile tests are conducted in ideal conditions with intact geomembrane specimens having a smooth surface. Such conditions do not exist in the field where the surface of geomembranes always contains a number of small scratches as a result of transportation, handling and installation of the geomembrane rolls.

The design engineer wrote a report describing the analysis and stating that the geomembranes would fail unless chamfers were constructed. The design engineer explained, in writing and in a meeting, that chamfers were indispensable because the geomembranes would otherwise fail under an average strain of the order of 12%, a strain value which was going to be reached in the vicinity of the corners of the reservoir under water pressure. However, the geomembrane supplier convinced the client (the physics experiment team) that the recommended chamfers were overly conservative because tensile tests show that HDPE geomembranes can elongate up to 700% before rupture (see Fig. 11). In other words, common sense dictated
